# Contribution to the Evaluation of Silicon Carbide Surge Arresters

Arnaldo Gakiya Kanashiro and Milton Zanotti Jr.  
*University of São Paulo  
Brazil*

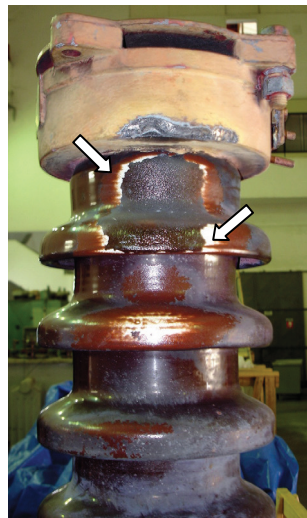
In some of the 88 kV arresters, surface erosion was observed which is a typical sign of electric arc damage on the porcelain, as shown in Fig. 1. Also, most of them had some degree of corrosion in their metallic parts, as shown in Fig. 2. Finally, in order to check the viability of measuring the leakage current in the field, some SiC surge arresters installed at Paraibuna substation were chosen. After this, due to the explosion of one 88 kV SiC surge arrester at Mairiporã substation, leakage current measurements were also performed in this substation.

Fig. 1. Typical sign of electric arc damage on the porcelain of the surge arrester.

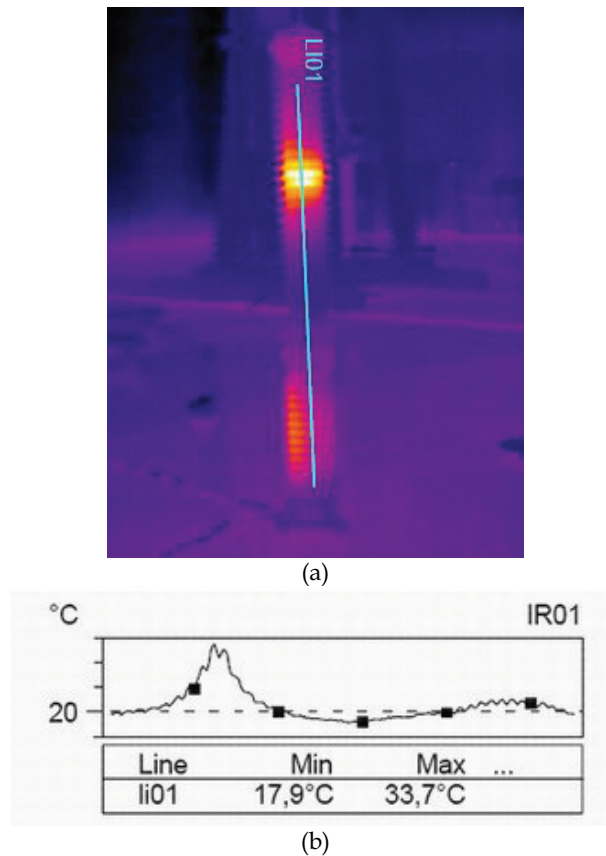
Fig. 3. Example of a thermal image measurement, (a) thermal image of the surge arrester and (b) temperature along the surge arrester.

- surge arrester C5 failed the power frequency spark-over voltage test and presented 3<sup>a</sup> H component of 7.5 % and phase difference of 83°;
- although surge arrester C6 was succesful in the power frequency spark-over voltage test, it presented leakage current amplitude of 0.726 mA, distortion of 18 % and phase difference of 51°, which may indicate some degradation of its internal components;
- surge arresters C5 and C6 had high RIV values, suggesting the presence of internal electrical discharges. In spite of this, the thermovision measurement showed higher temperature only in surge arrester C6.

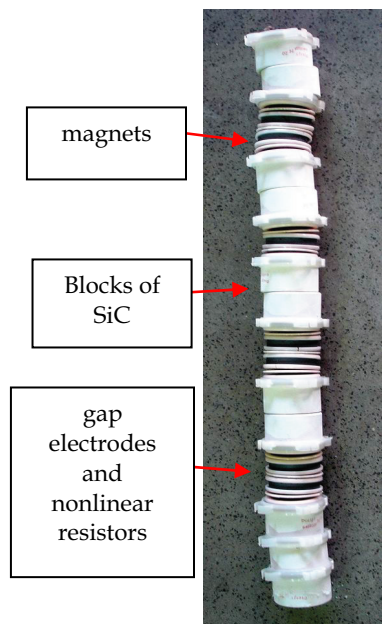
In the surge arresters A2, A4 and A6 there are permanent magnets in parallel with gap electrodes. Nonlinear resistors of SiC are placed between the gap electrodes. The dismantled surge arrester of manufacturer A can be seen in the Fig. 4.

Fig. 4. Surge arrester of manufacturer A.

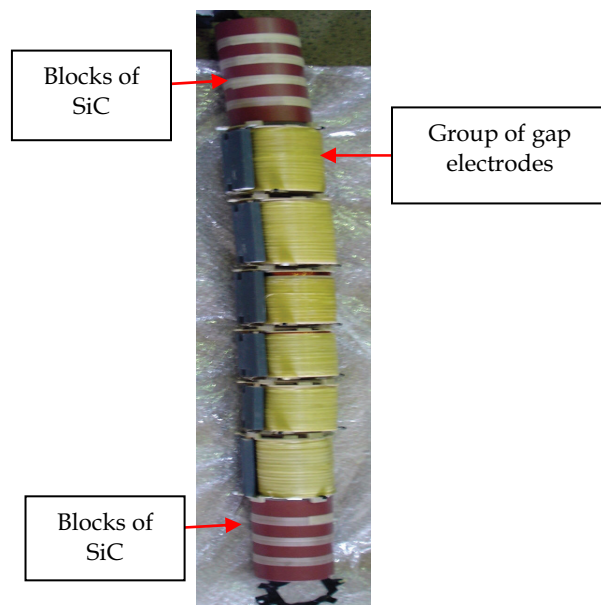
The internal components of the surge arrester C can be seen in Fig. 5. At the edges are placed coils in order to facilitate arc extinguishing. Fig. 6 shows one group of gap electrodes.

Fig. 5. Surge arrester of manufacturer C.

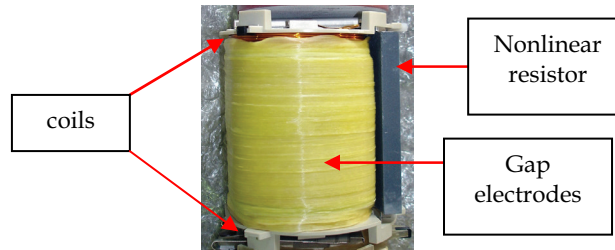
Fig. 6. Group of gap electrodes of surge arrester C.

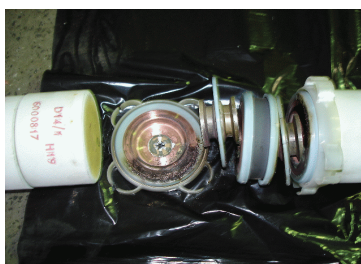
The surge arrester A6 (manufacturer A) was more degraded in comparison with A2 and A4. The arrester C5 (manufacturer C) was the worst in comparison to the surge arresters C1 and C3.

As a general conclusion, it was observed that the surge arresters of manufacturers A and C presented evidence of ingress of moisture and signs of discharges. Moisture ingress may have deteriorated the SiC material (McDermid, 2002) and (Grzybowski, 1999).

Fig. 7. Surge arresters of manufacturer A, (a) blocks: signs of discharge, (b) gap electrodes: signs of discharge, (c) block: presence of moisture and (d) gap electrode: signs of discharge.

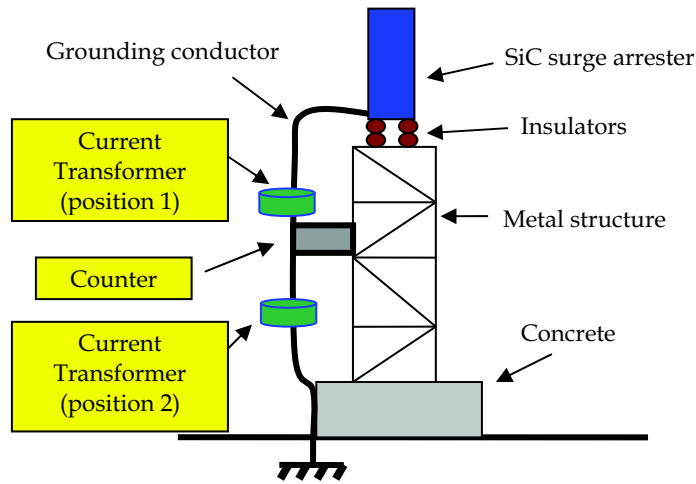
Fig. 9. Leakage current measurement at the substation.

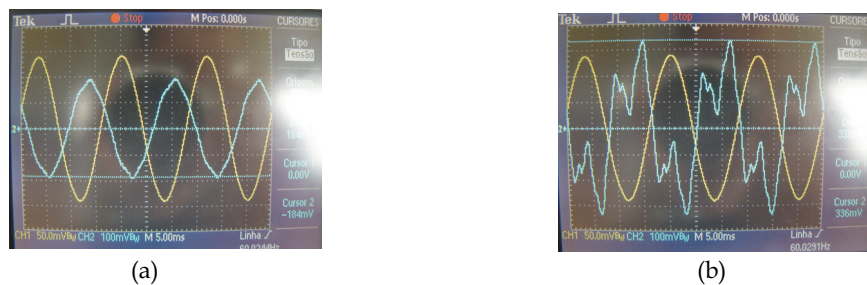
Fig. 10. Waveforms of the leakage current (blue) and of the applied voltage (yellow), (a) CT in the position 1 and (b) CT in the position 2.
