Evaluation of Distribution Line Spacers through the Leakage Current Monitoring

Abstract: This paper presents measurements of leakage current aiming at the utilisation of this parameter to indicate the degradation of polymeric material of distribution line spacers and covered cables. Tests were performed at the laboratory in order to investigate the behaviour of the leakage current as function of the stage of degradation of polymeric material. The results showed that the leakage current can provide valuable information about the degradation, in particular, with the frequency of occurrence of the ratio of third harmonic (I_3) to fundamental 60 Hz component (I_3/I_1). Investigations are being carried out in order to define reference values to be used in the field. A device is being developed and is intended for indication of maintenance in case of tracking and erosion of the polymeric material in distribution lines located near the coast.

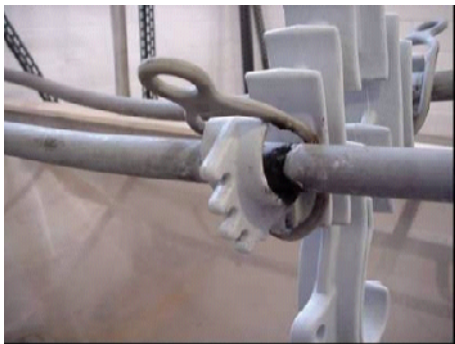
Figure 3 –Degradation after laboratory test.

The results to be present in this work refer to one of the sets tested. The degradation was observed after 540 hours of test (March 11). Figure 3 shows the spacer and the degradation of cable. Figure 4 shows the magnitudes of I_1 and Figure 5 shows the measurements of I_3 and I_5 . The behaviour of the harmonic components can be observed as a function of the proximity of the degradation (erosion) of the cable occurred on March 11. Figure 6 shows results of measurements of the harmonic ratio I_3/I_1 .

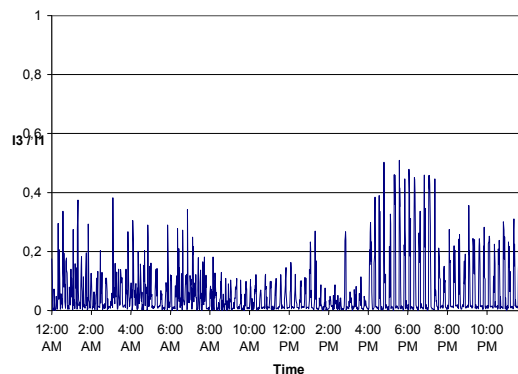
Figure 6 – Harmonic ratio I_3/I_1 .

about 0.6. On March 9, the highest values registered were about 0.4 until 2:00 pm. On March 11, values of ratio I_3/I_1 increased at the time that the erosion on the surface of the cable was observed (4:00 pm).
